Mobile Intel[®] Pentium[®] II Processor Specification Update

Release Date: May 2001

Order Number: 243887-031

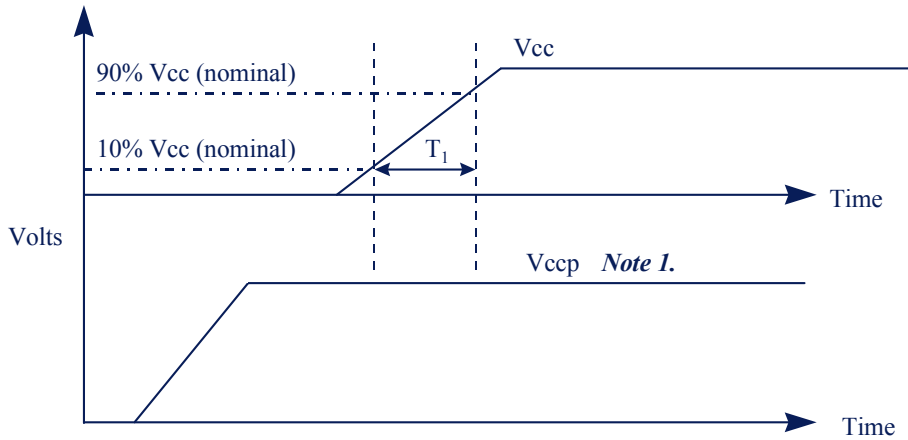
Figure 1. V_{CC}/V_{CCP} Timing Requirements (Mobile)

Problem: The processor uses the PWRGOOD signal to ensure that no voltage sequencing issues arise; no pin assertions should cause the processor to change its behavior until this signal is asserted, when all power supplies and clocks to the processor are valid and stable. However, if V_{CC} ramps up before V_{CCP} , it will cause the processor to enter an invalid state.

Implication: If this erratum occurs, the system may boot normally however, the L2 cache may not be initialized.

Workaround: For Mobile Pentium II processors, ensure that V_{CC} ramps after or with the L2 cache IO voltage (V_{CCP}). If V_{CCP} ramps after the V_{CC} , a delay circuit can be placed on the core V_{CC} to ensure that V_{CC} ramps at the same time or after V_{CCP} as shown below in Figure 1.

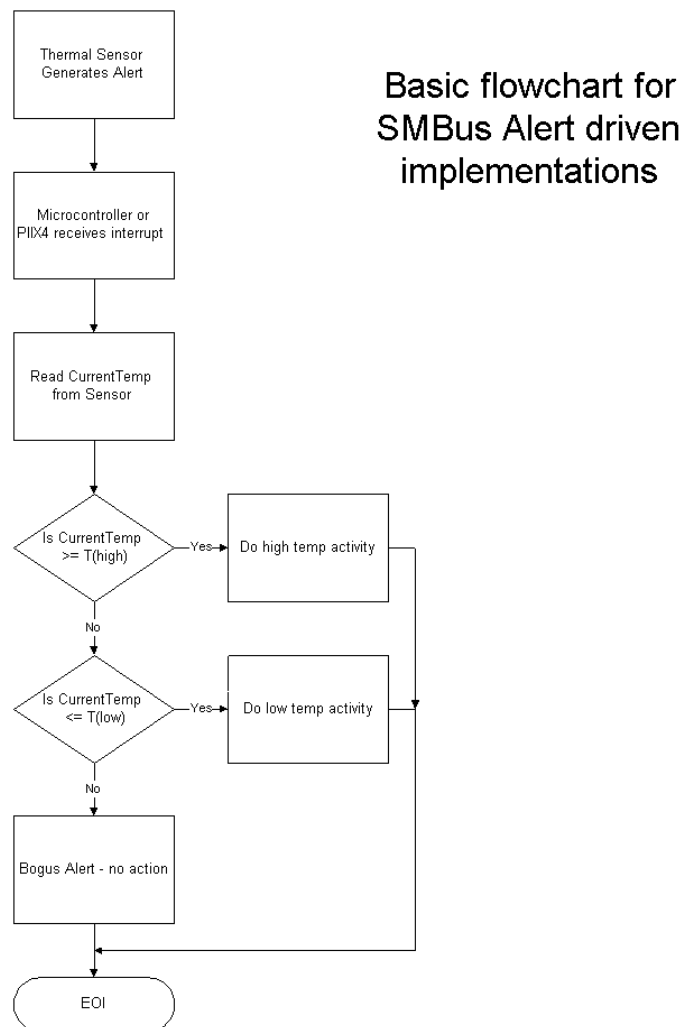
Figure 2. Workaround Flowchart: SMBALERT#-Driven System

B30. Thermal Sensor May Assert SMBALERT# Incorrectly

Under the conditions described below, the thermal sensor incorrectly generates the SMBALERT# interrupt. All of the following conditions must be met to trigger a false interrupt:

1. Before servicing an interrupt from the thermal sensor, read and compare the processor thermal reading with the threshold limits (T_{HIGH} or T_{LOW}). Figures 2 and 3 provide basic flowcharts for the implementation of this workaround in an interrupt driven system.
2. If the firmware implemented polls the Status Register only, then before taking any action, re-read the temperature register and do a comparison with the alarm threshold limits (T_{HIGH} or T_{LOW}) to determine if the value is actually still within the temperature window.

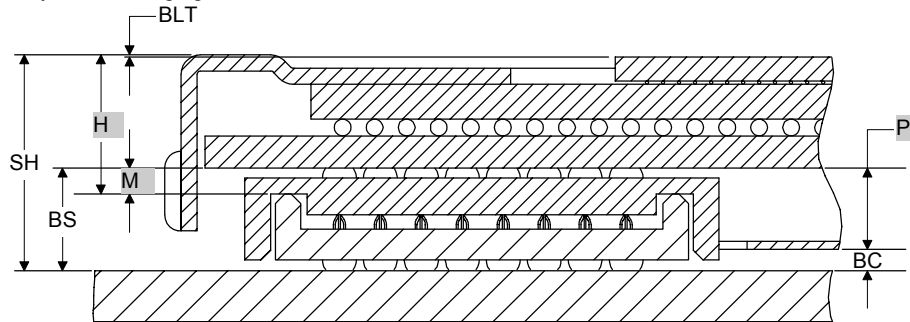
Figure 5.6. Cross Sectional View with Vertical Dimensions

B1. Misabeled Vertical Dimension Parameters

Figure 5.6 in the *Mobile Pentium® II Processor at 233 MHz, 266 MHz, and 300 MHz* datasheet should be replaced by the following figure:

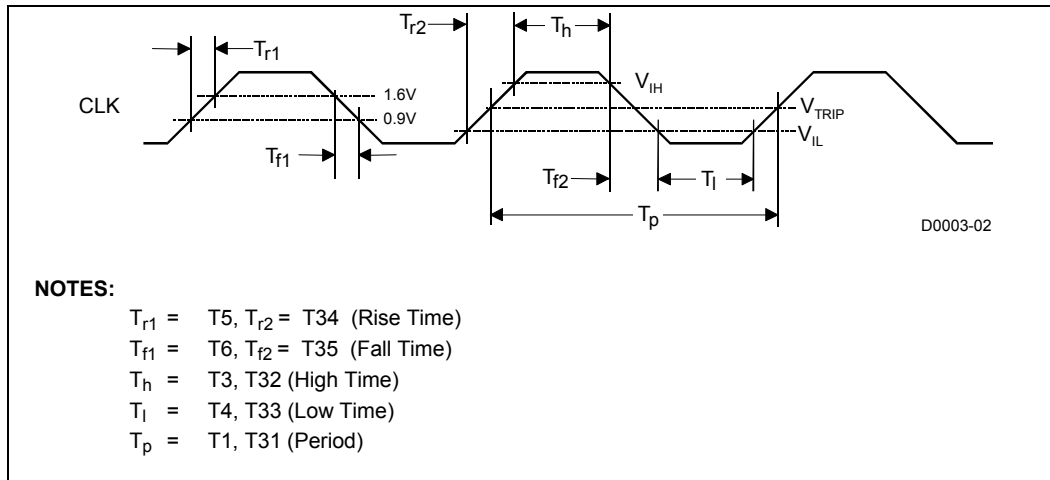
Figure 3.3 Generic Clock Waveform

B14. Generic Clock Waveform Figure

Figure 3.3 in *Mobile Pentium® II Processor in Mini-Cartridge Package at 366 MHz, 333 MHz, 300PE MHz, and 266PE MHz* datasheet (Order Number 245108), and the *Mobile Pentium® II Processor in BGA Package at 366 MHz, 333 MHz, 300PE MHz, and 266PE MHz* datasheet (Order Number 245106) has been updated. The following figure is to replace the ones in the above documents.
